Rescuing

St James's, Llangua, Monmouthshire

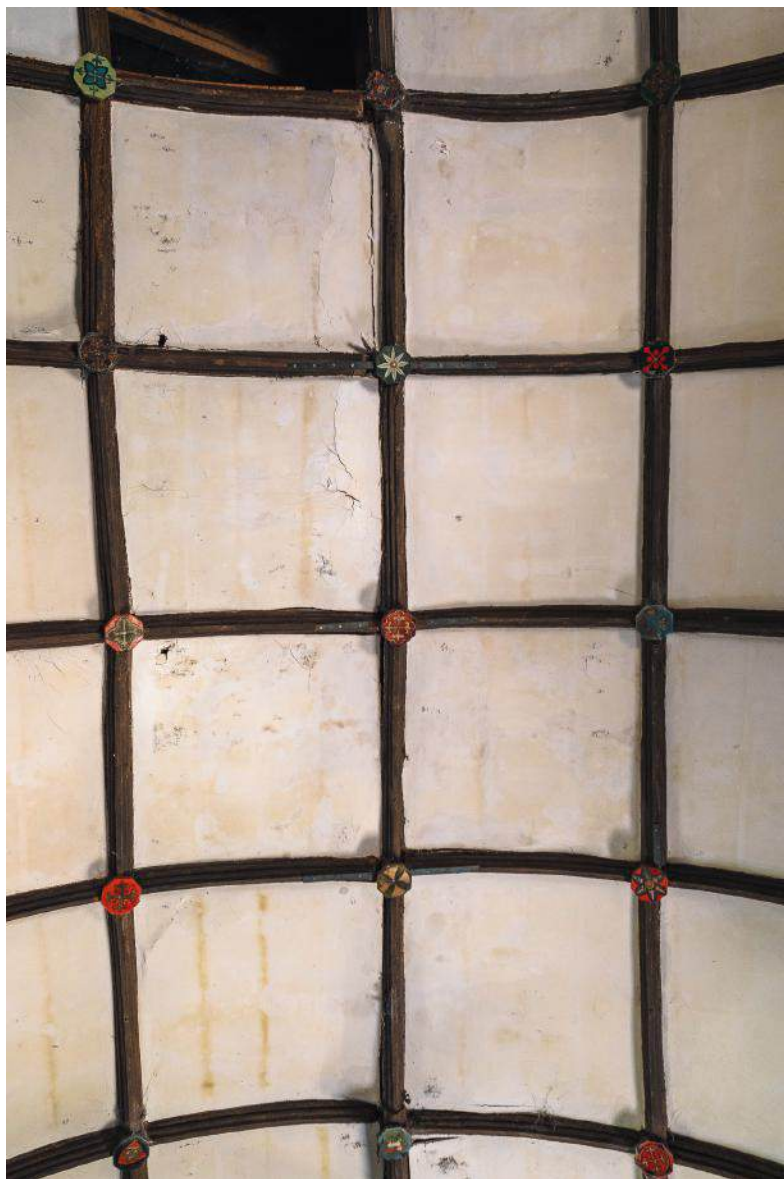
In 2019, the church was in use. What started as a social visit, quickly became much more serious. There were clearly structural issues. With permission, I commissioned Andrew Faulkner, architect, to undertake a full assessment of the condition. Andrew immediately advised that we prop the timber wall-plate on the north elevation of the nave, which barely had 20mm of bearing on the stone wall below.

The ceiling before we started

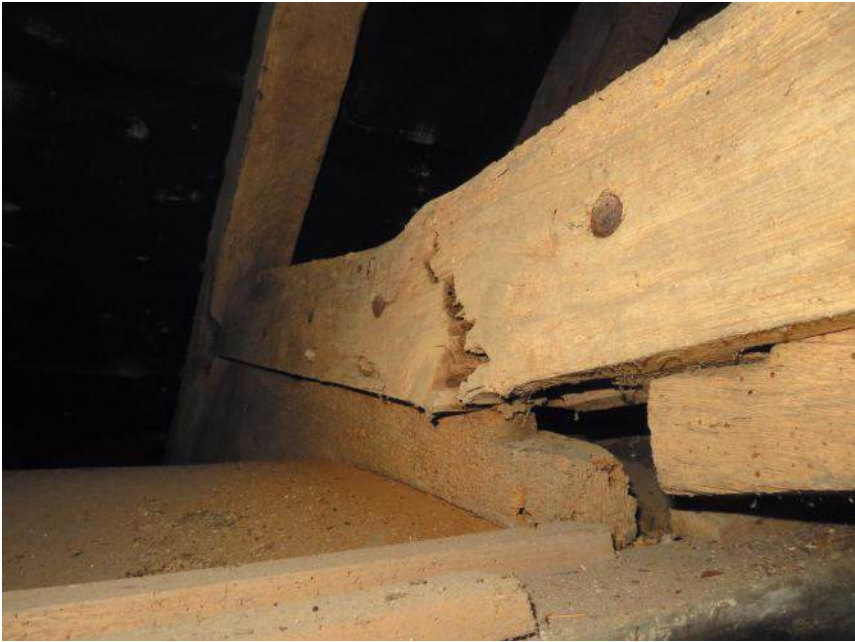
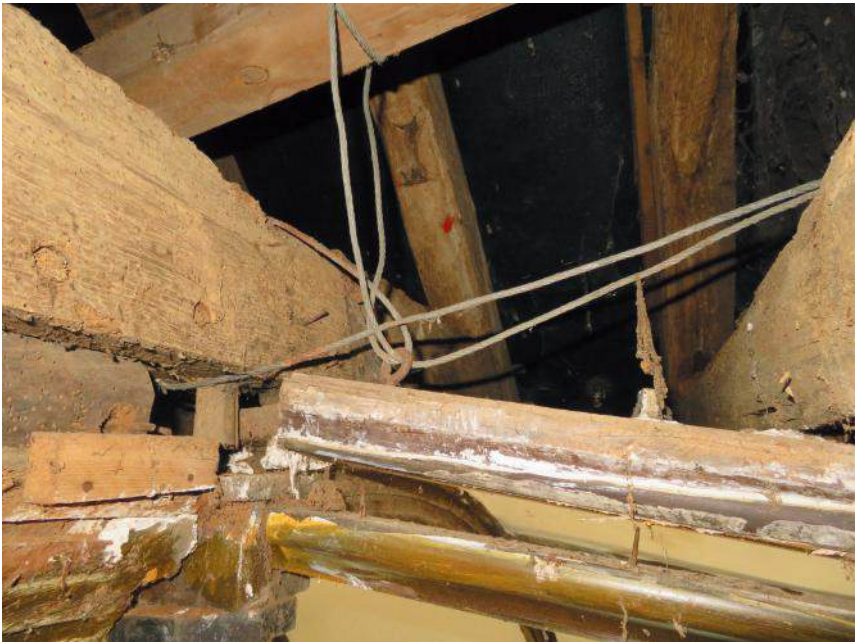
Snapped trusses

Stainless steel plates were bolted onto the trusses to increase their capacity to carry the weight of the tiles, and the timbers that could be salvaged were repaired using traditional joinery techniques. This included planing, by hand, metres of roll moulding, cutting new ribs, notching in new collars, and splicing new oak into old.

After 3 months of squeezing, jacking, sawing, splicing and plenty of replacement we had the trusses close enough to transfer the weight of the roof back to where it was originally intended. Each truss was then carefully templated in its entirety and strengthened with 10mm stainless steel along its side.

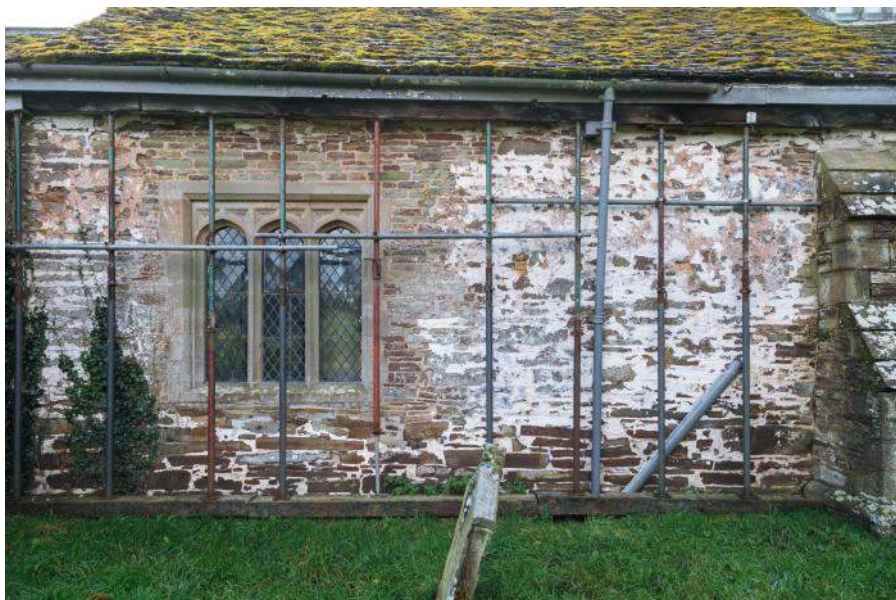
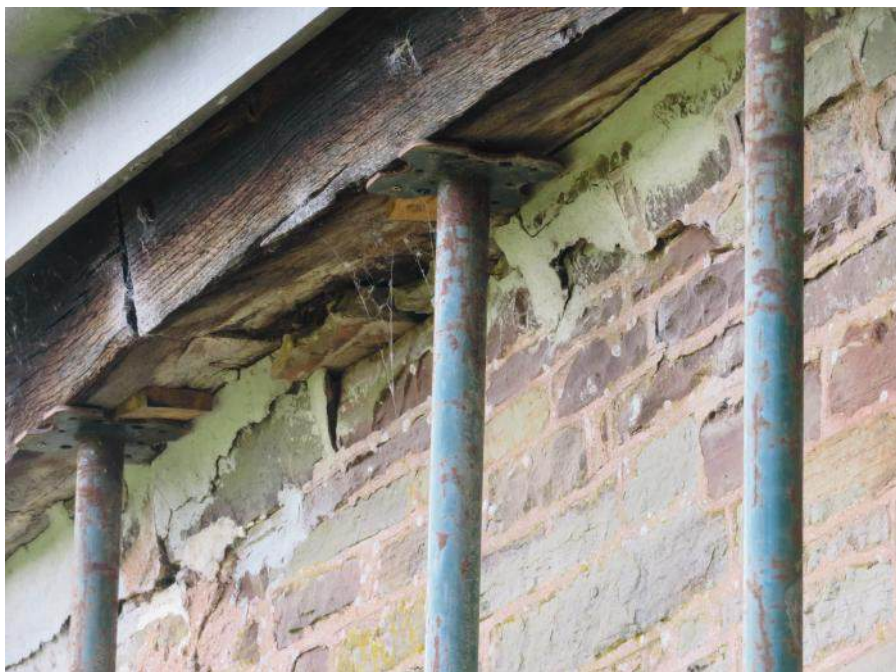
Top: Scaffold poles supporting the wall-plate on the north side
 Bottom: Showing extent wall-plate had pushed off the stone wall

The timber wall-plate, which was rotten in parts, was repaired and replaced as necessary. The stone wall-heads underneath these, which had been pushed and dislocated by the moving roof, were reset.

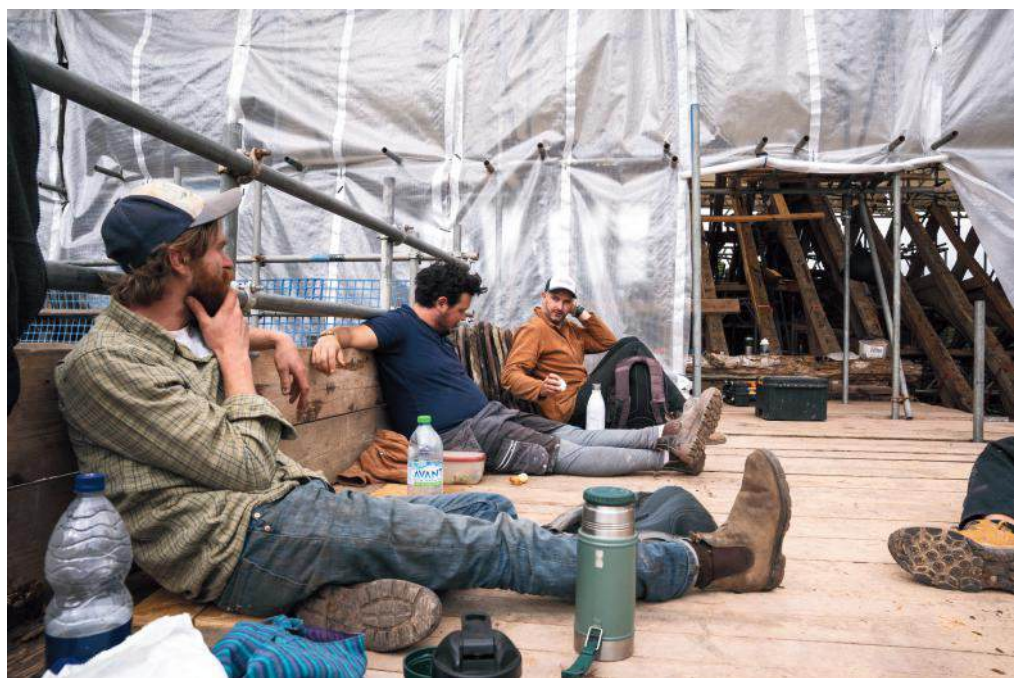
The structural drawings showed a web of stainless steel, cranked beams, brackets, flitch plates, tie rods, Cintec pins, heli-ties, threaded bars, plates and turnbuckles. At first glance

It might look heavy handed but one needs to remember this building and roof structure was initially designed to take the weight of a thatch roof, not 300 years of a 32 ton diminishing stone tile roof that now sits on it.

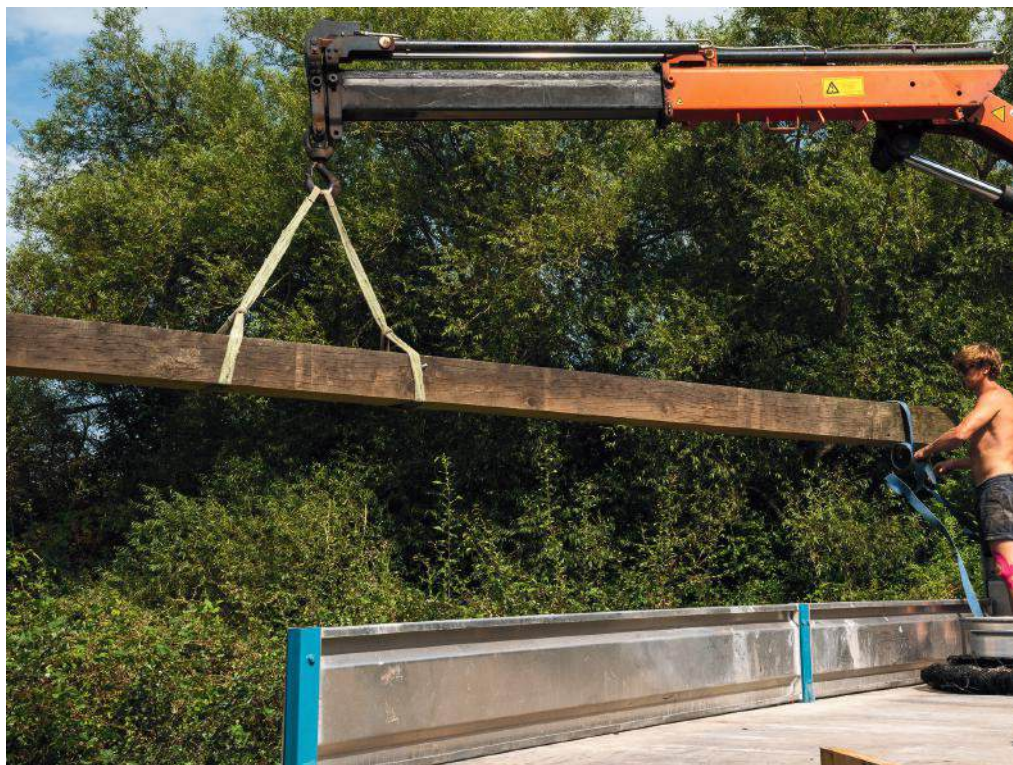
A new oak wall-plate is delivered to site

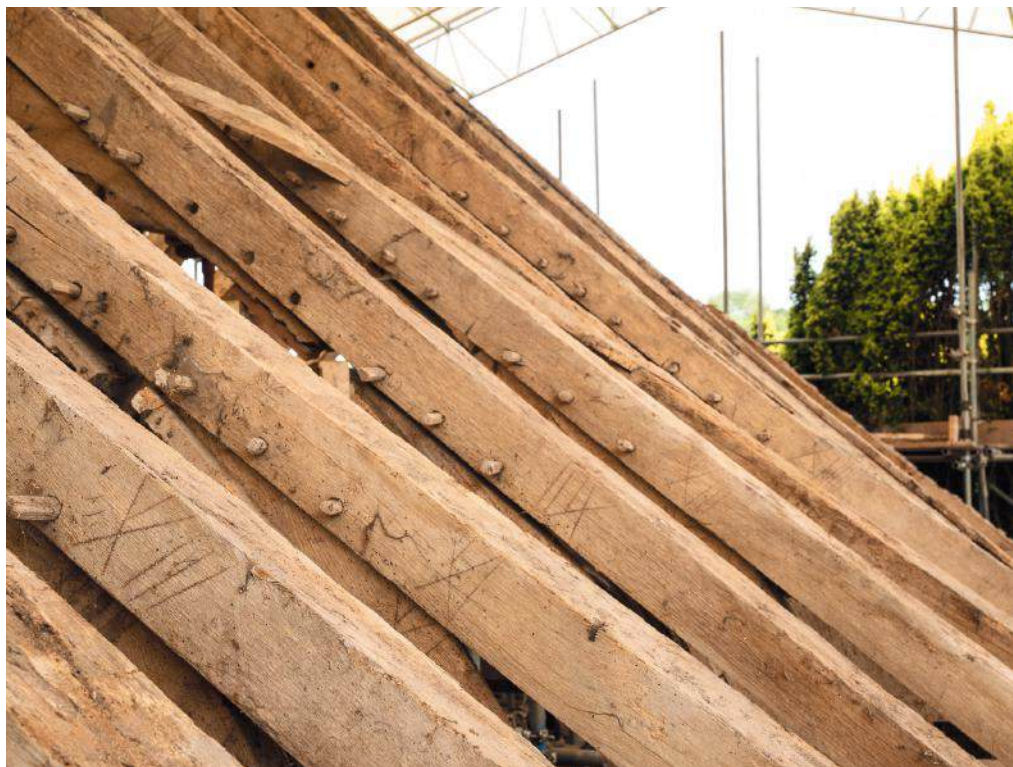
The three distinct marks suggest the trusses were made by three different carpenters.

Carpenters' marks

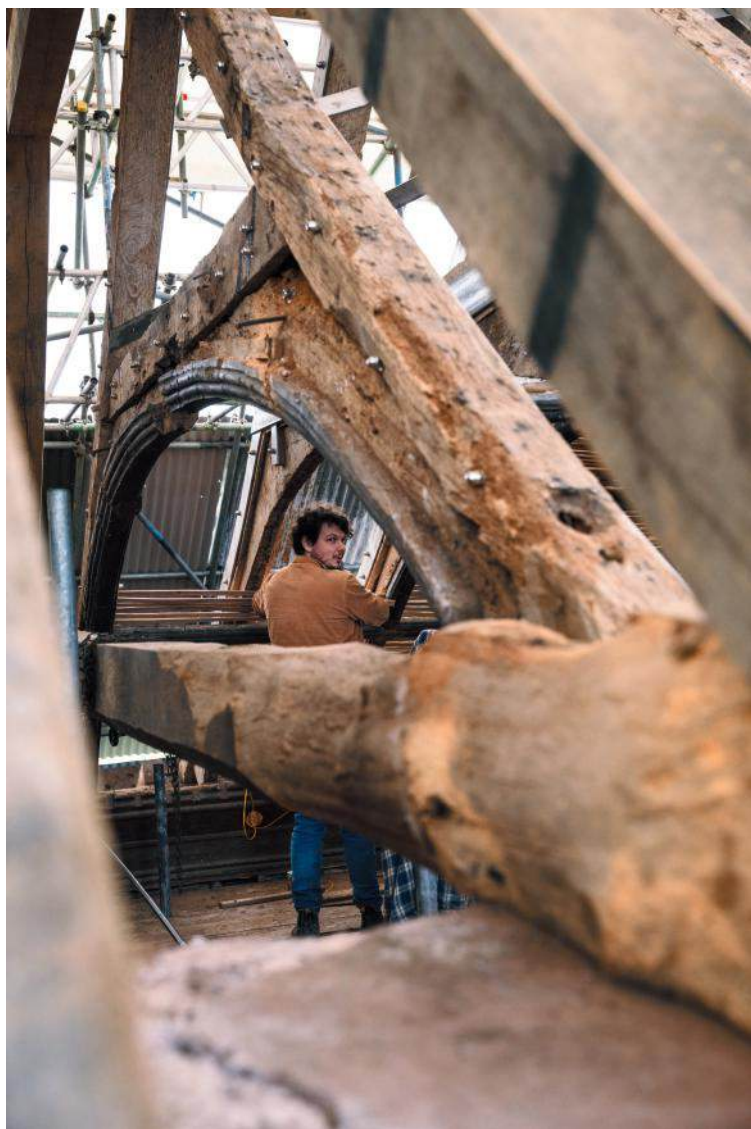
Louis manoeuvring riven oak laths into position

The ceiling was re-lathed using riven oak. Ingeniously the medieval carpenters who had built the roof had come up with a system where the laths could slot into a groove on every other truss, thus reducing the number of nails to be used by two thirds. We used stainless steel nails in order to extend the lifespan of the ceiling which was plastered using the same materials and methods as the rest of the interior.

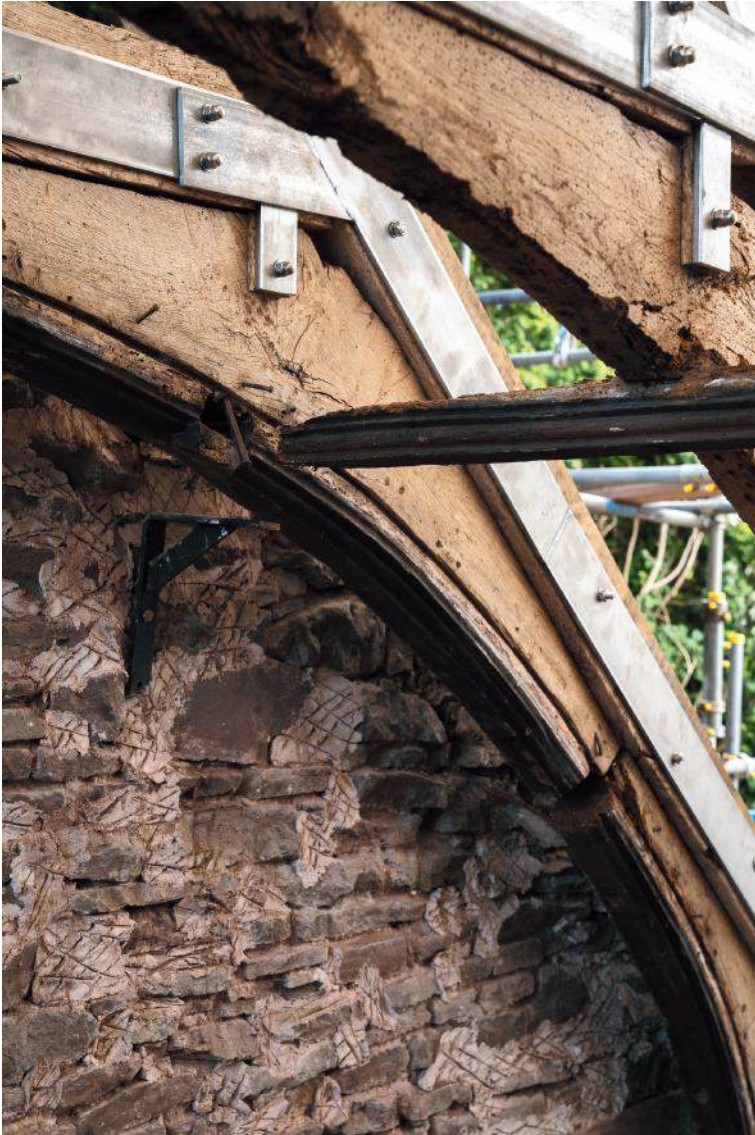
The local authority insisted that we retain the sandstone tile covering. The roof timbers could not support a stone roof, even if repaired, so it was necessary to install stainless steel plates and ties.

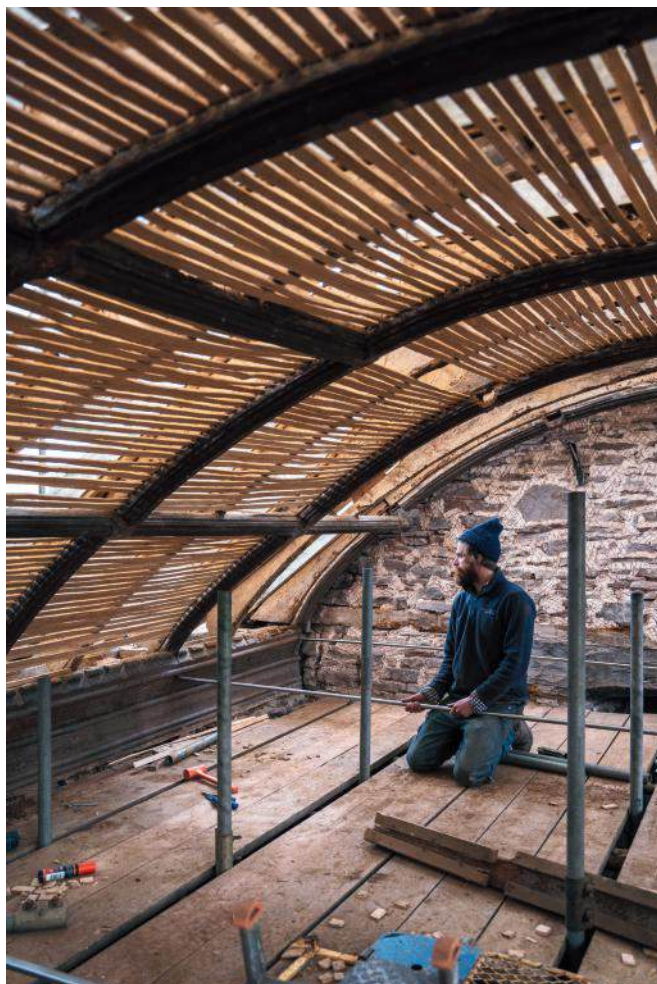
The roof is back in alignment and the laths have all been inserted, ready to be plastered. Jack adjusting a new stainless steel tie-bar.

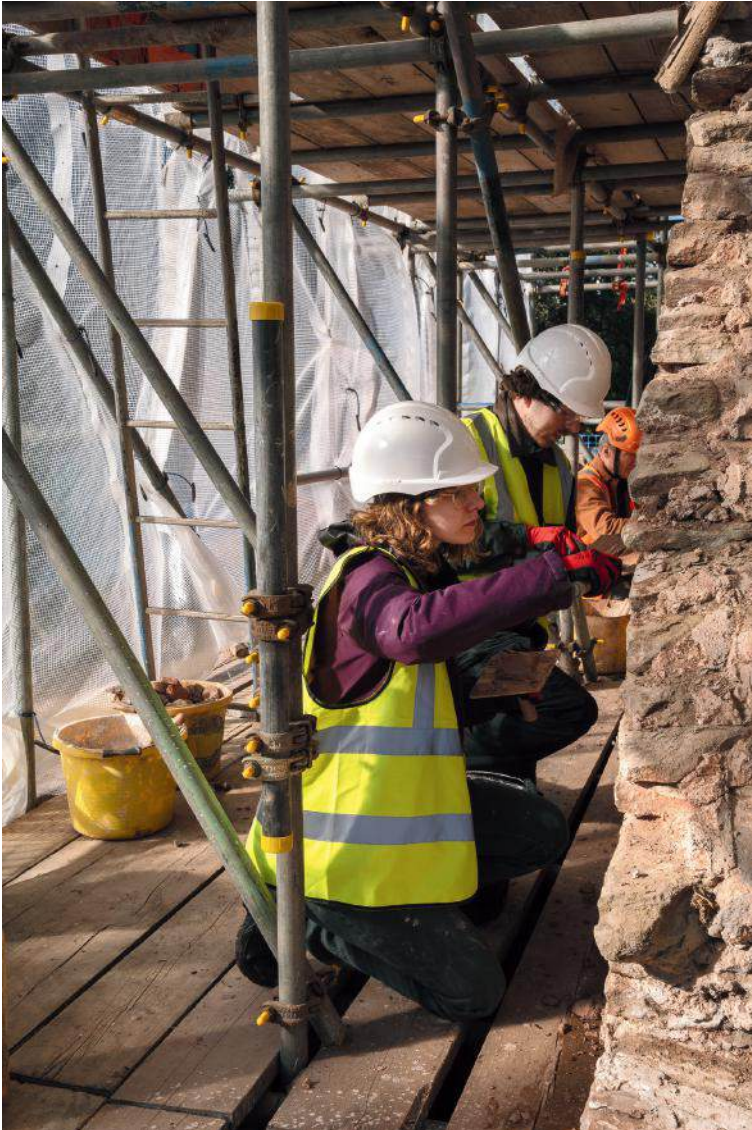
Volunteers using hot-mixed lime to repoint the west gable

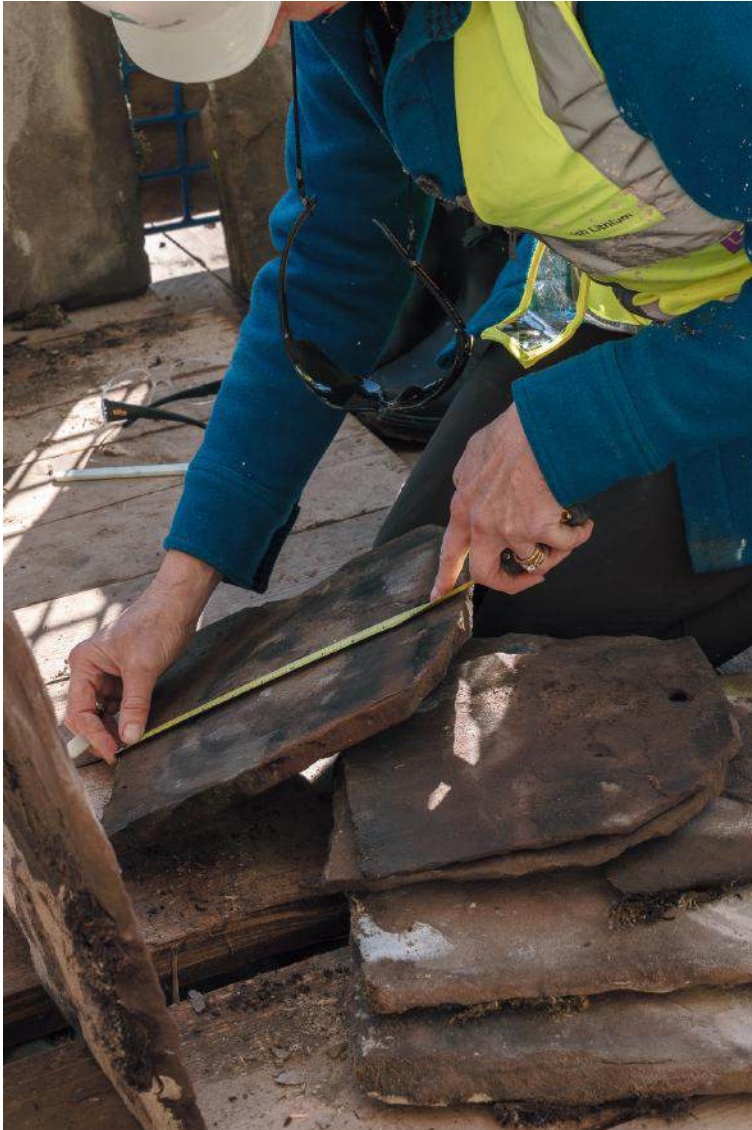
Measuring and organising tiles to create a slope of tiles gradually diminishing in size

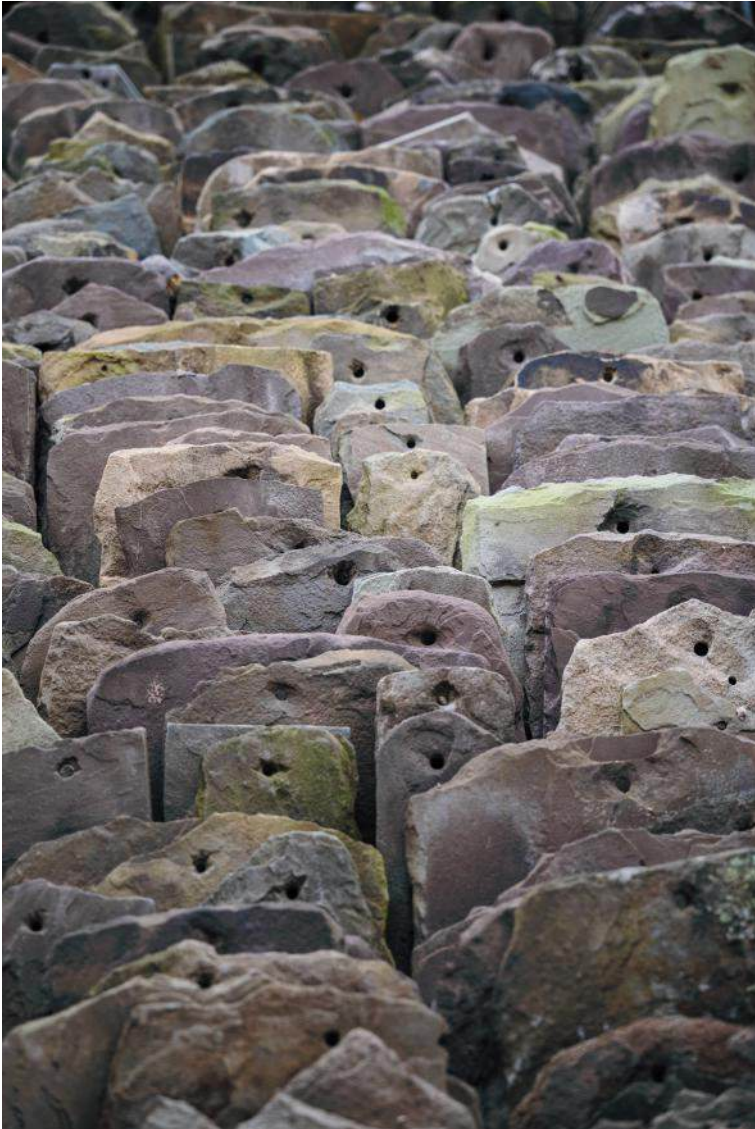
Roof tiles arranged ready to be re-used

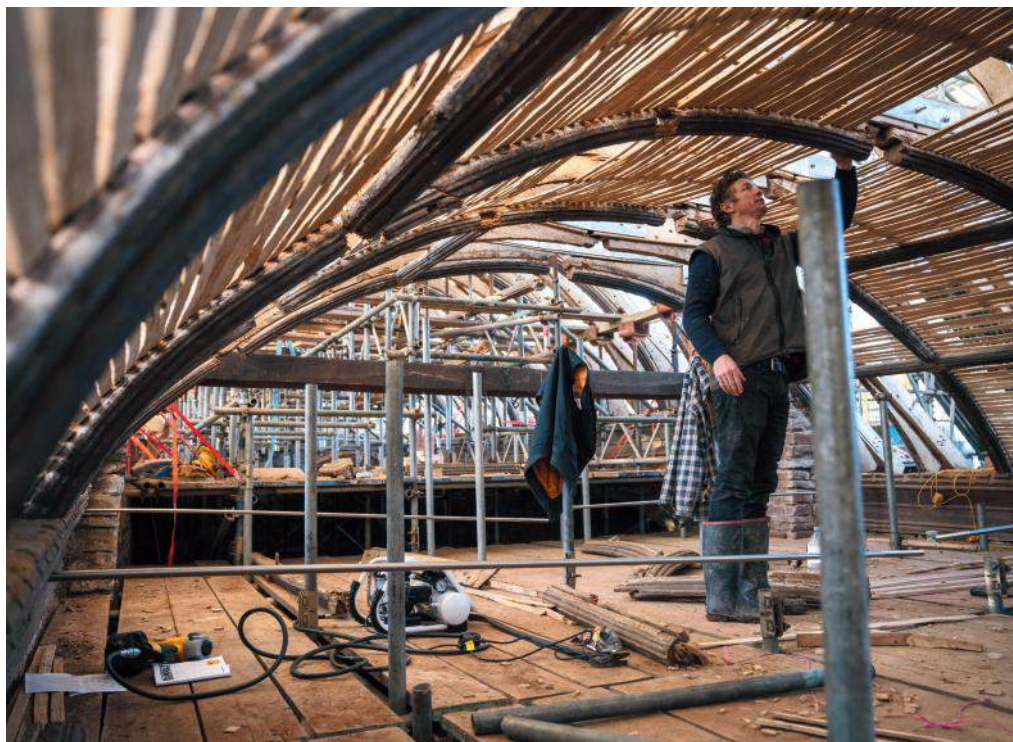
Tom Jones examines a reformed truss
